DROP MECHANISM LUBRICATION

Periodic lubrication of the drop mechanisms will insure smooth, crisp drops. We recommend that you use 3-IN-ONE oil after about 500 adjustments or once/month, whichever comes first. If the drops have not been lubricated on a regular basis, it is recommend to first clean the plungers using WD-40. See instructions below.

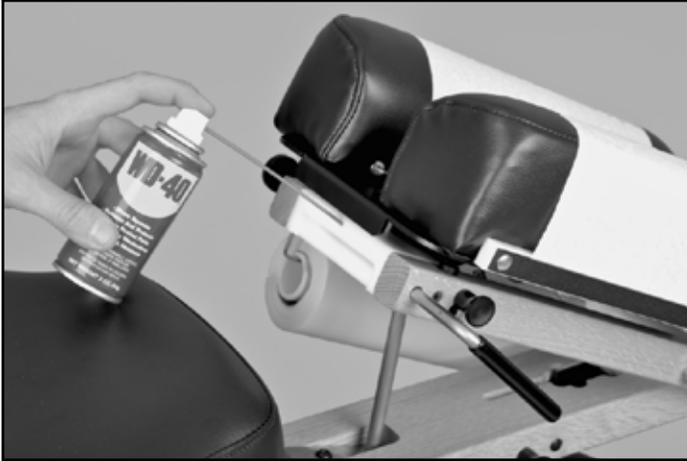
CERVICAL DROP

1. Raise the back of the headpiece.
2. Apply 3-IN-ONE into the hole of the white drop mechanism housing as shown in the photo. Allow a few minutes for the lubricant to penetrate the mechanism before using the headpiece drop.

1. First clean the plunger from accumulated dust and debris by applying WD-40 (as shown above) and then drop the headpiece several times.
2. Apply 3-IN-ONE oil to lubricate the drop (as described above).

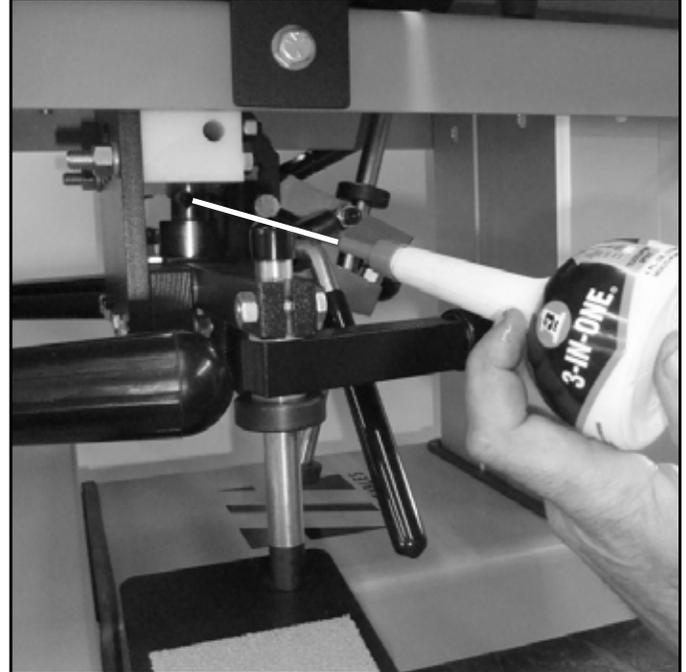
THORACIC & PELVIC DROPS

1. Lubricate the drops while in a neutral (un-cocked) position. Locate the drop mechanisms on the underside of the table. Apply 3-IN-ONE onto the metal plungers.
2. Cock the drops and leave them for a few minutes to allow the lubrication to penetrate the mechanism before using the drops.

1. First clean the plungers from accumulated dust and debris by applying WD-40 (as shown above) and then drop the sections several times.
2. Apply 3-IN-ONE oil to lubricate the drops (as described above).

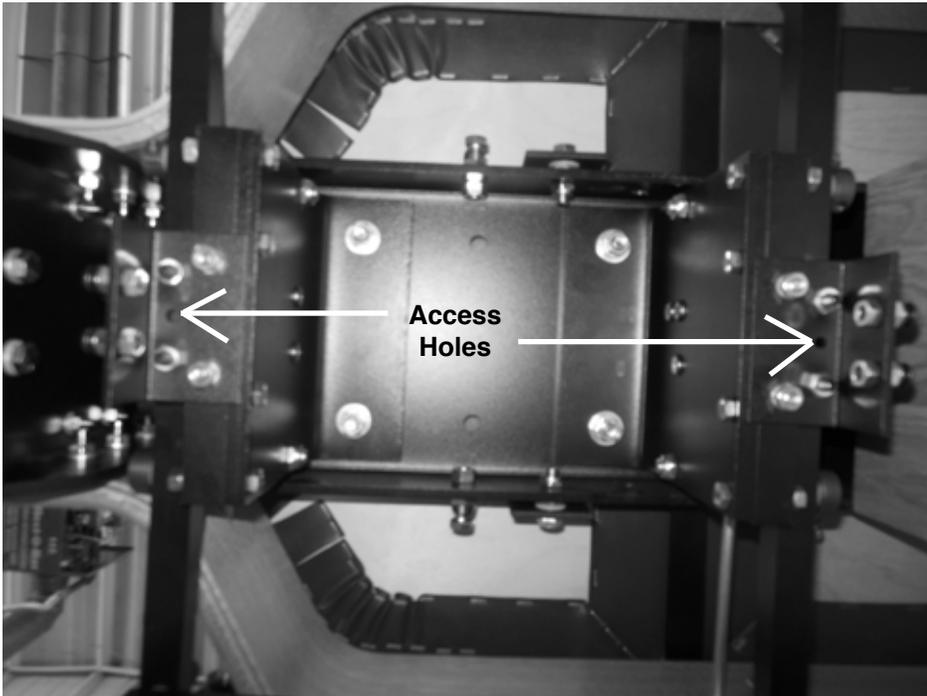
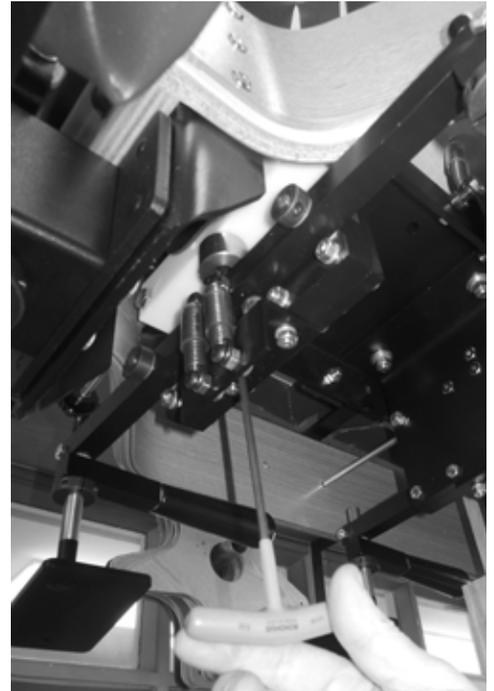
THORACIC & PELVIC STRIKE PLATES

Periodic tightening of the thoracic and pelvic drop mechanism strike plates will assure proper functioning and reduce wear on the cocking arms. We recommend doing this approximately once/month.

Locate the access hole in the angle bracket of each drop. Using the allen wrench provided, insert it through the hole and locate the screw to tighten the strike plate. Tighten the screw firmly. Do this on both of the thoracic and pelvic strike plates.
